# Manhole Inspection Summary

Manhole # S31EE\_013MH

Insp Date: **1/30/07 8:32 AM**

**Location** Address: **307 DOLPHIN ST**

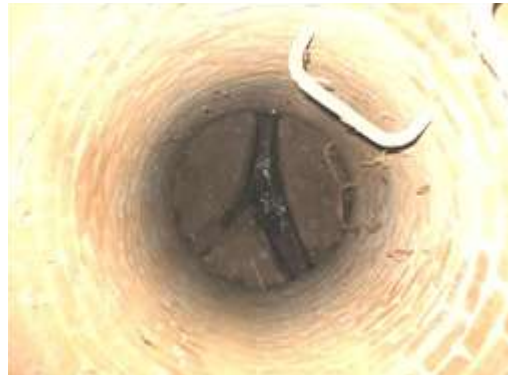
Top View

Corroded and missing steps. Bench and Channel debris.

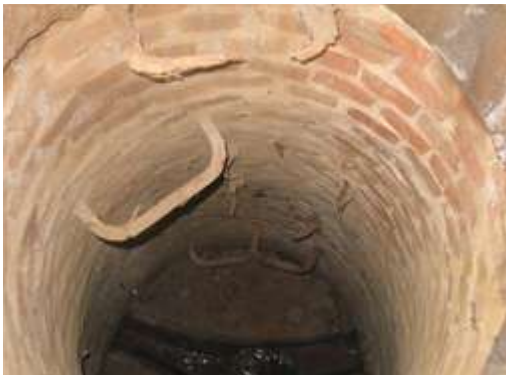
Defect

Frame leaks. Adjustment, Corbel and Barrel infiltration.

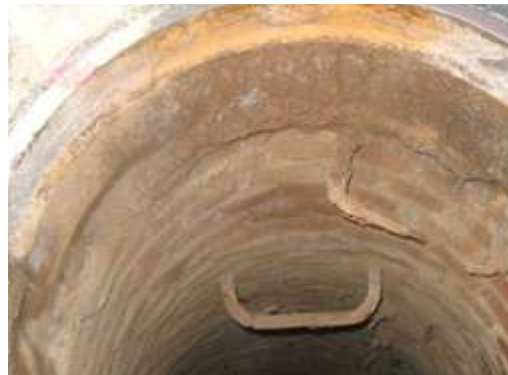
Defect

Frame leaks. Adjustment, Corbel and Barrel infiltration.

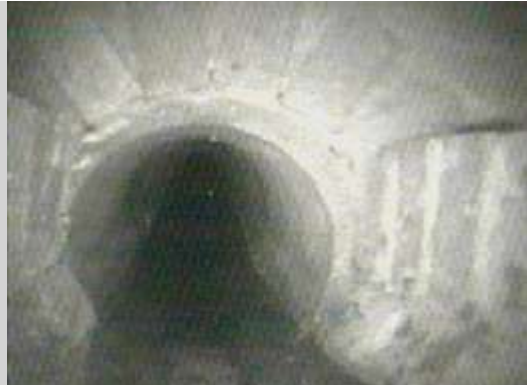
### 8 in. Circular Gravity Sewer Pipe Out @ 12 O'Clock

Invert Depth: **12.60** (ft.) Flow Characteristics: **Slow**

Infiltration: **Evidence** Pipe Seal Cond: **Unknown**

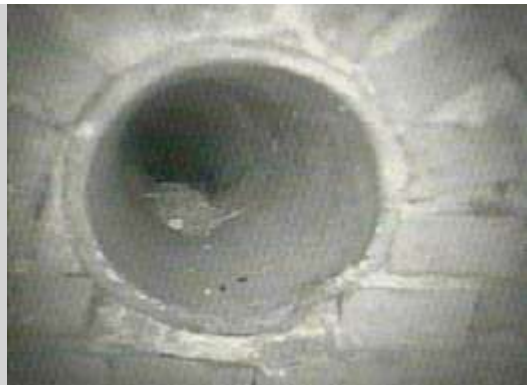
### 8 in. Circular Gravity Sewer Pipe In @ 5 O'Clock

Invert Depth: **10.98** (ft.) Flow Characteristics: **Slow**

Infiltration: **Evidence** Pipe Seal Cond: **Unknown**

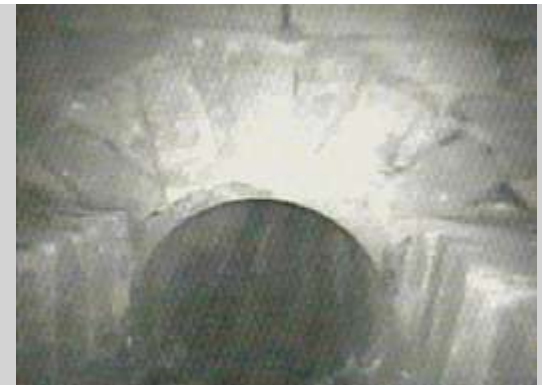
### Drop In @ 5 O'Clock

Drop: **Outside** Rod and Bar

Drop Condition: **Open**

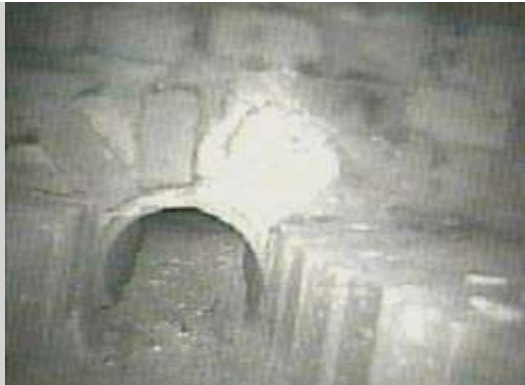
Pipe In @ 7 O'Clock

Deposits: ☐ None ☒ **Mud** ☐ Sludge ☒ **Debris** ☐ Grease

Silt Depth: **2** (in.)

Deposits Extent: **Medium**

Infiltration: **Evidence**

Connects To: **Dead End**
